CALSPAN ON-SITE NON-DEPLOYMENT AIR BAG INVESTIGATION
CALSPAN CASE NO. 92-20
LOCATION - [REDACTED] ME
ACCIDENT DATE - [REDACTED] 1992

Contract No. DTNH22-87-C-27169

16. Abstract This on-site investigation focused on a low-speed crash that involved a police 1992 Chevrolet Caprice that was equipped with a Supplemental Inflatable Restraint (SIR) system which consisted of a driver's side air bag. The vehicle impacted a wooden utility pole with the right frontal area that resulted in 28.4 cm (11.2") of bumper crush. The damage and trajectory mode of the CRASHPC program was utilized to compute an impact speed of 23 KPH (14 mph) and a total (longitudinal) velocity change of 21 KPH (13 mph). The velocity change was below the manufacturer-reported 24 KPH (15 mph) centerline pole impact deployment threshold for this vehicle and therefore, the driver air bag system did not deploy. The driver of the vehicle was a 50 year old on-duty police officer. He was wearing a bulletproof vest; however, he was not wearing the manual 3-point lap and shoulder belt system. At impact, he initiated a forward trajectory and loaded the steering assembly with his thoracic area. His loading force compressed the e

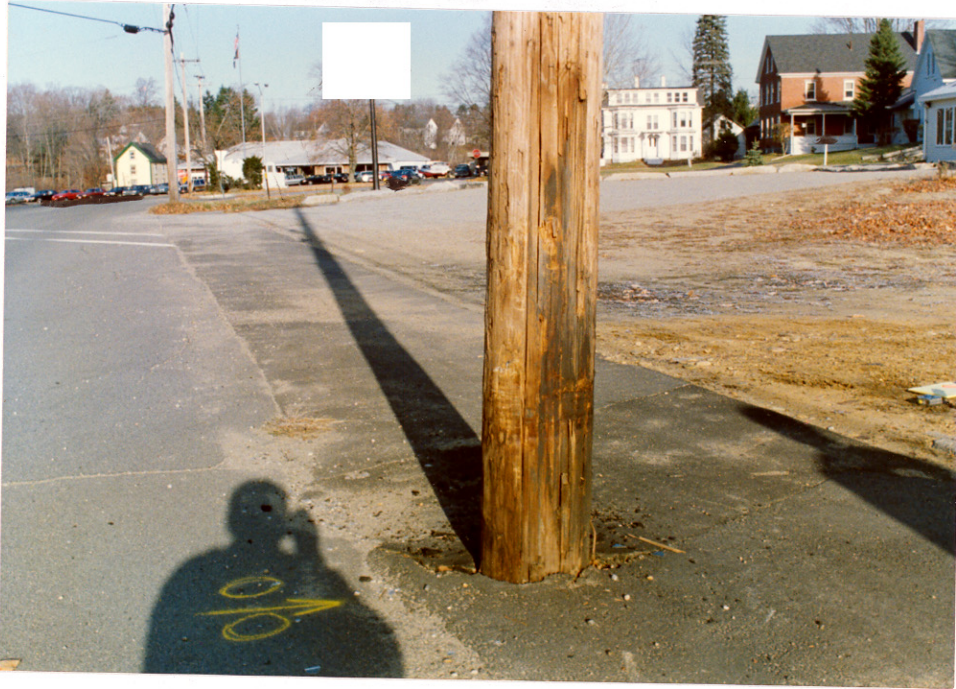
Struck utility pole

The right front bumper area of the Chevrolet Caprice impacted a 25.4 cm (10") diameter wooden utility pole that was located 0.4 m (1'4") outboard of the right roadedge. The officer estimated his impact speed at 15-20 mph. The 12 o'clock direction of force impact produced a maximum of 28.4 cm (11.2") of bumper crush located 41.7 cm (16.4") right of center. Direct contact damage began 23.9 cm (9.4") right of center and extended 31.8 cm (12.5") to the vehicle's right. The combined induced and direct contact damage was 164.5 cm (64.75") which involved the entire width of the front bumper. Crush values at bumper level were as follows: $c_1=2.3$ cm (.9"), $c_2=6.1$ cm (2.4"), $c_3=12.4$ cm (4.9"), $c_4=20.1$ cm (7.9"), $c_5=20.1$ cm (7.9"), $c_6=6.1$ cm (3.0"). Damaged components included the front bumper facia, bumper reinforcement bar, grille, right headlamp assembly, radiator support panel, and the hood. The preliminary repair estimate was \$3,522.57.

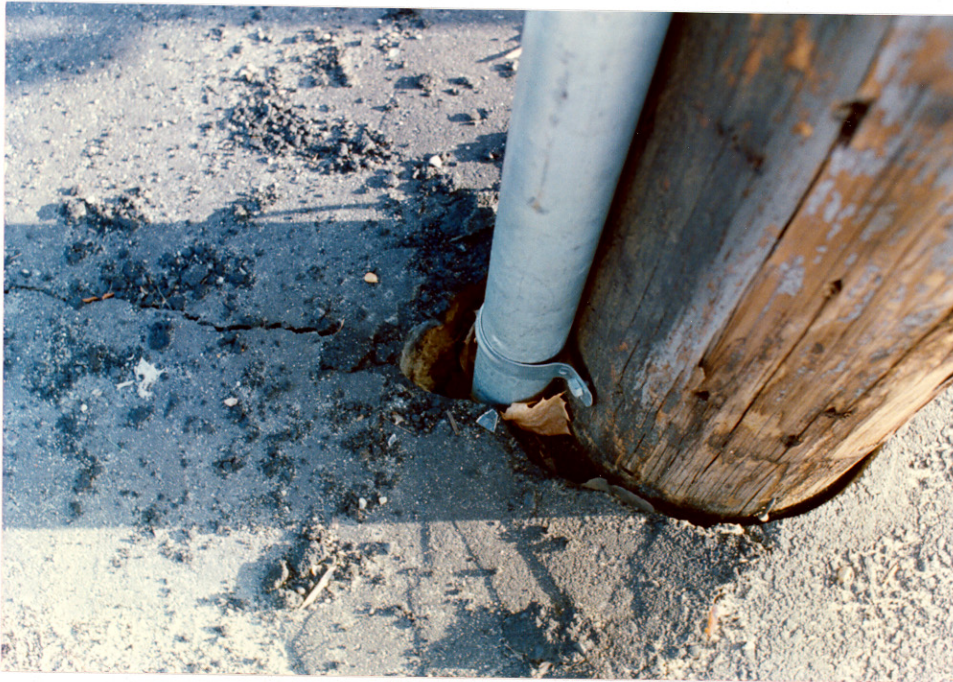
7cm (2.75") displacement of pole

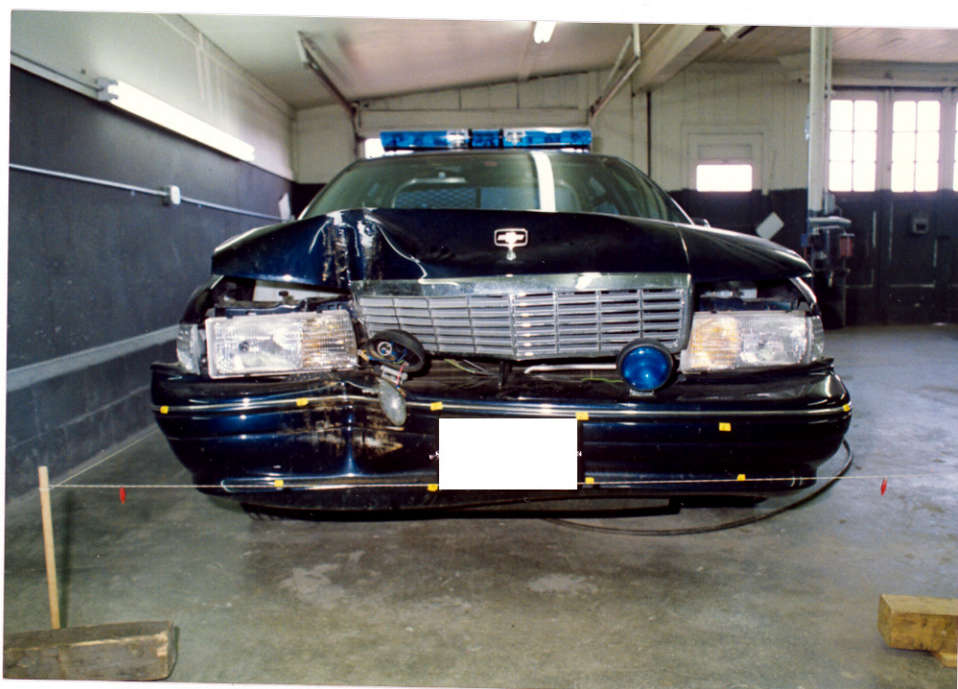
Frontal view of the Chevrolet Caprice

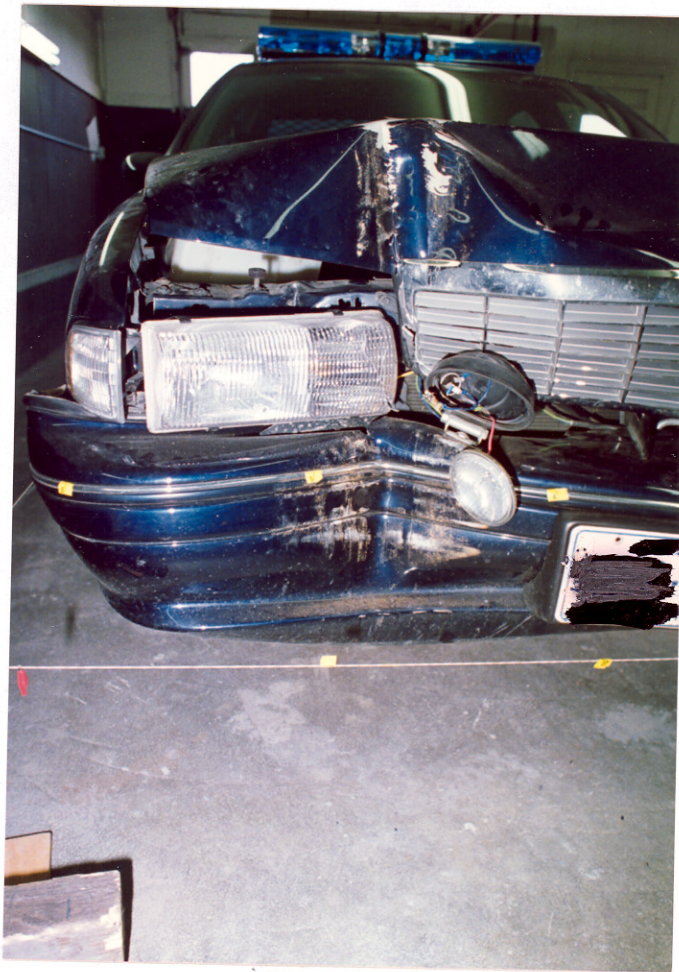
Close-up view of the utility pole impact damage

Exterior: The right frontal area of the 1992 Chevrolet Caprice impacted a 26.7cm (10.5") diameter wooden utility pole that was located 0.4m (1.3') outboard of the right roadedge. Direct contact damage began on the front bumper fascia 23.9cm (9.4") right of center and extended 31.8cm (12.5") to the right. The contact damage extended vertically onto the headlamp lens, grille and hood face. The 12 o'clock direction of force impact crushed the bumper reinforcement bar to a maximum depth of 28.4cm (11.2"), located 41.7cm (16.4") right of center. As a result of the impact with the narrow object, the entire width of the bumper was displaced. The combined induced and direct contact damage length was 164.5cm (64.75"). Crush values at bumper level were as follows:

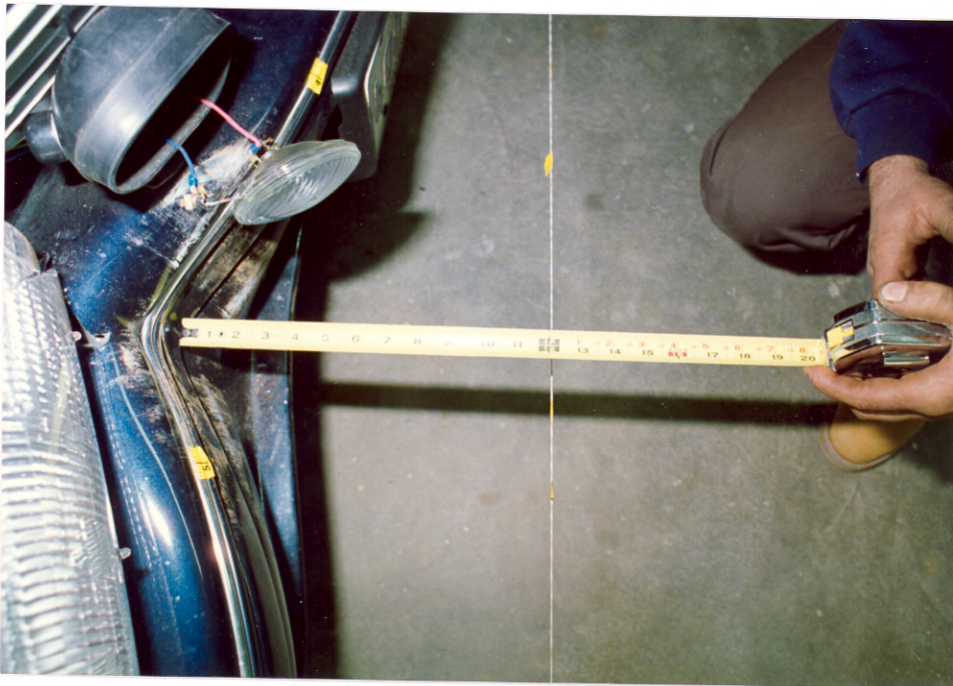
Overhead view showing the extent of crush

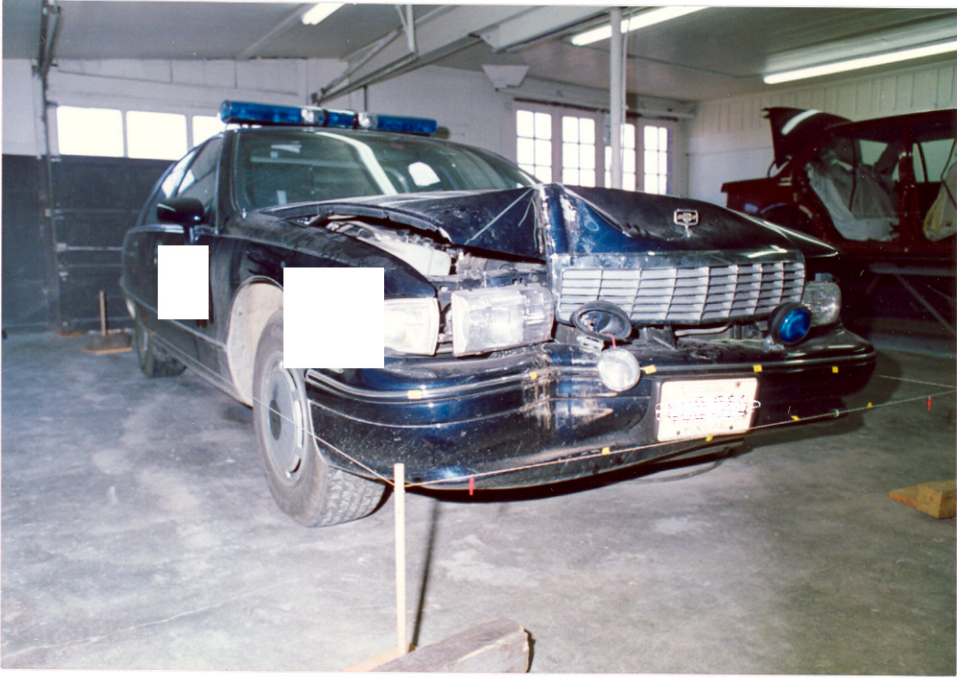
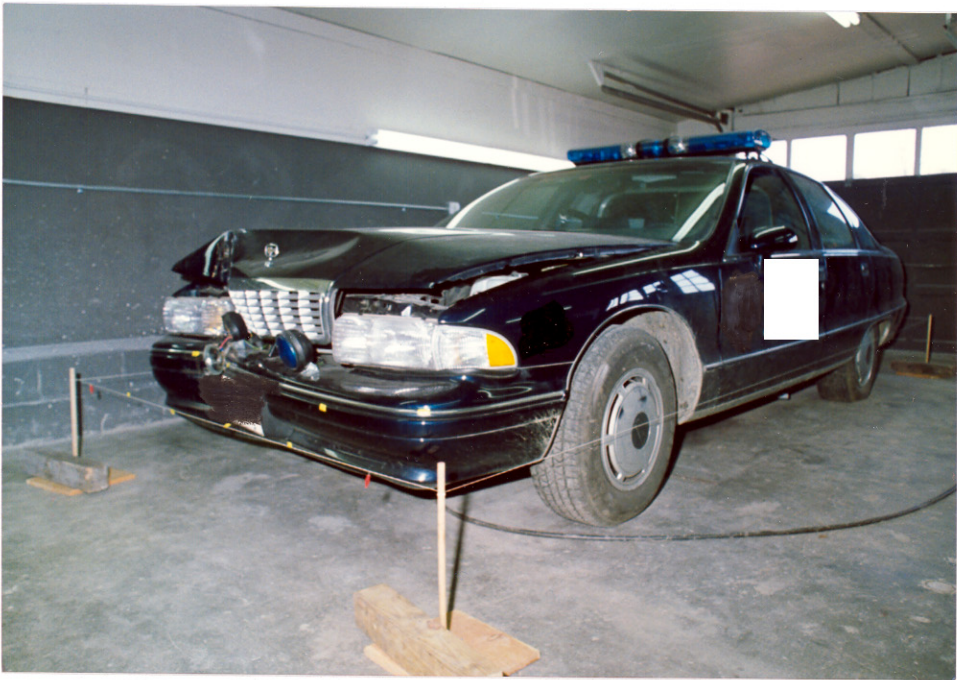
Front three-quarter views

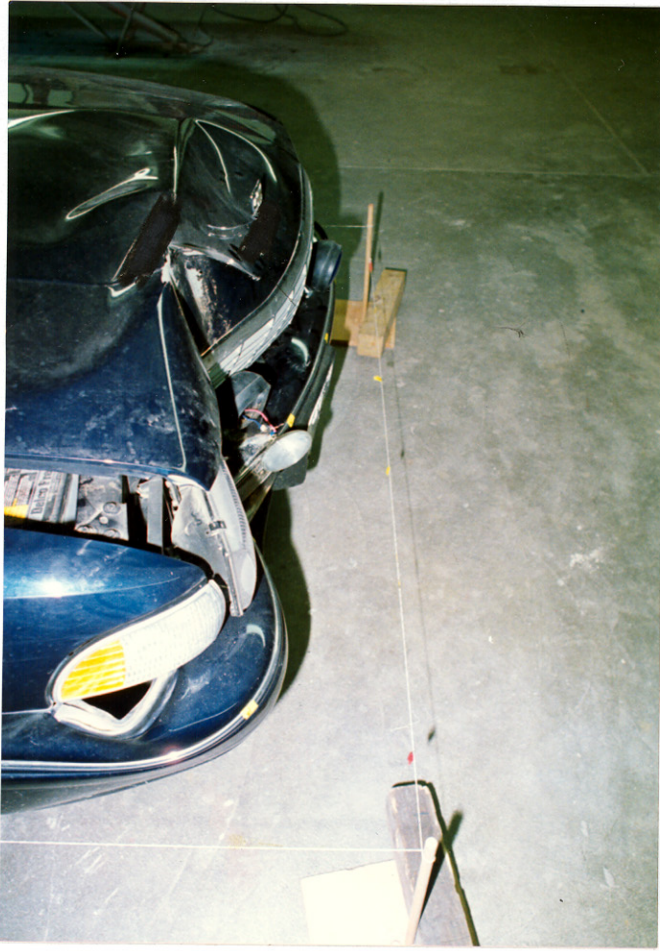
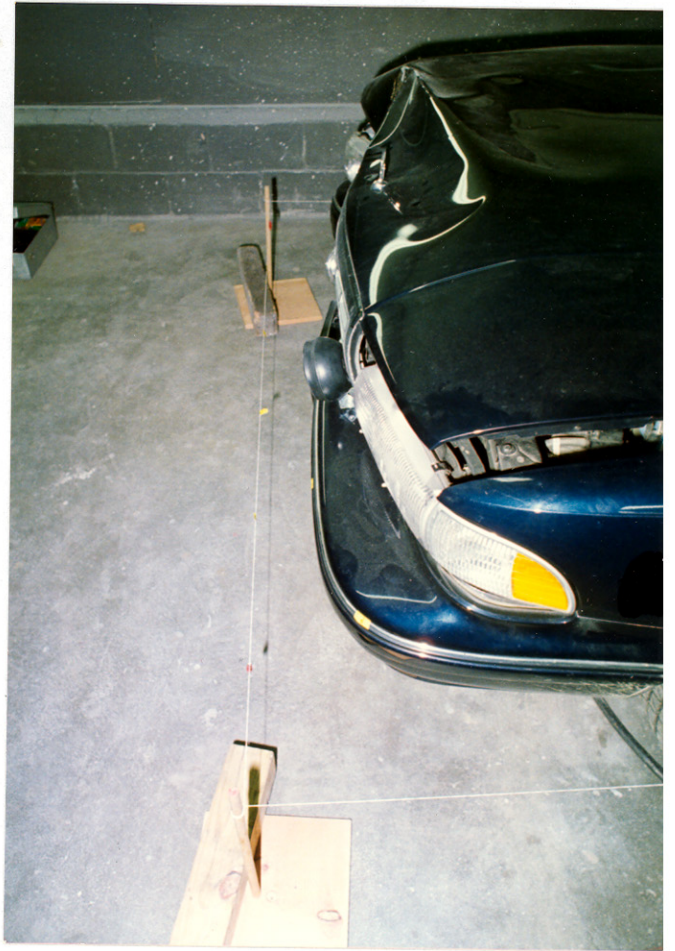
Perpendicular views showing the extent of crush

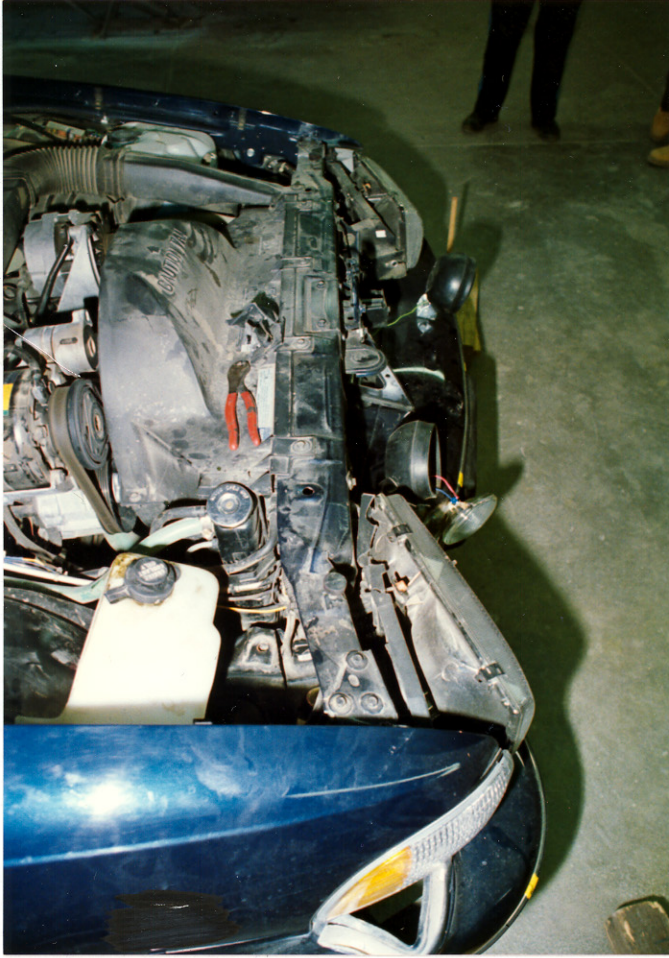
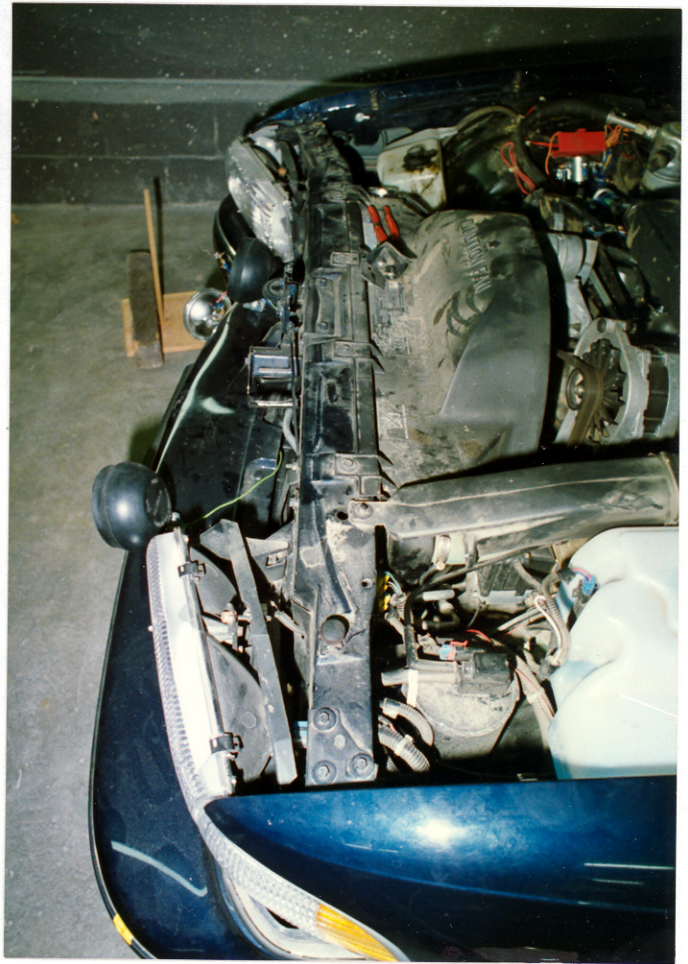
Damaged radiator support panel of the involved Chevrolet Caprice

The utility pole impact buckled the upper rail of the radiator support panel and displaced the right frame rail which resulted in a 1cm (0.4") reduction of the right wheelbase. Damaged components included the front bumper facia, bumper reinforcement bar, both front bumper energy absorbing devices (EADs), right frame rail, right headlamp assembly, grille, radiator support panel, and the hood. The radiator, air conditioning condensor and the battery, all located directly rearward of the pole impact damage, were not damaged by the crash.

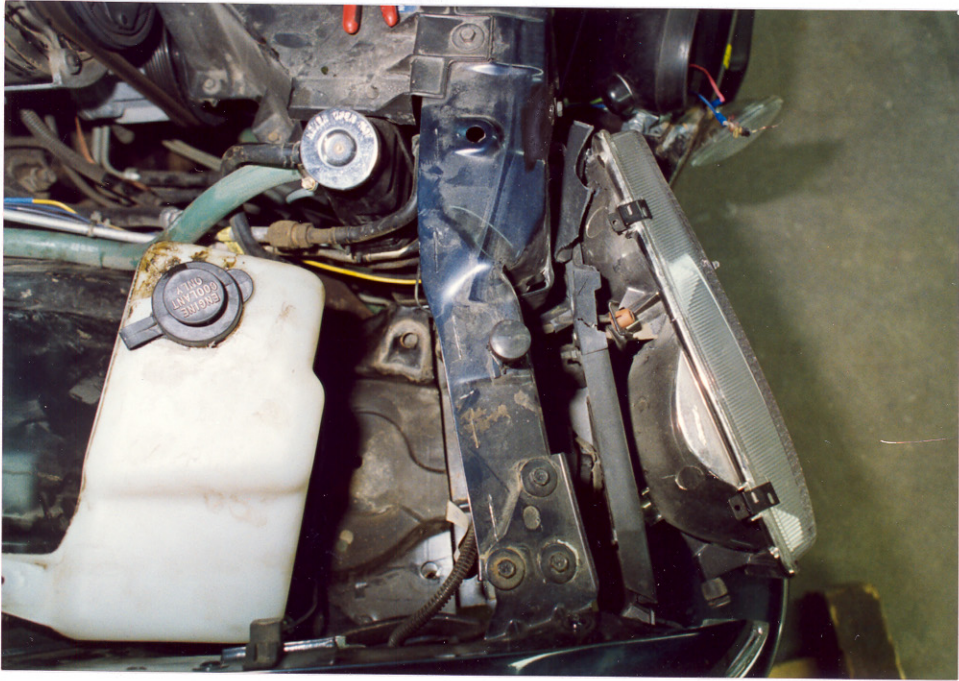
Area surrounding the right front air bag discriminating sensor

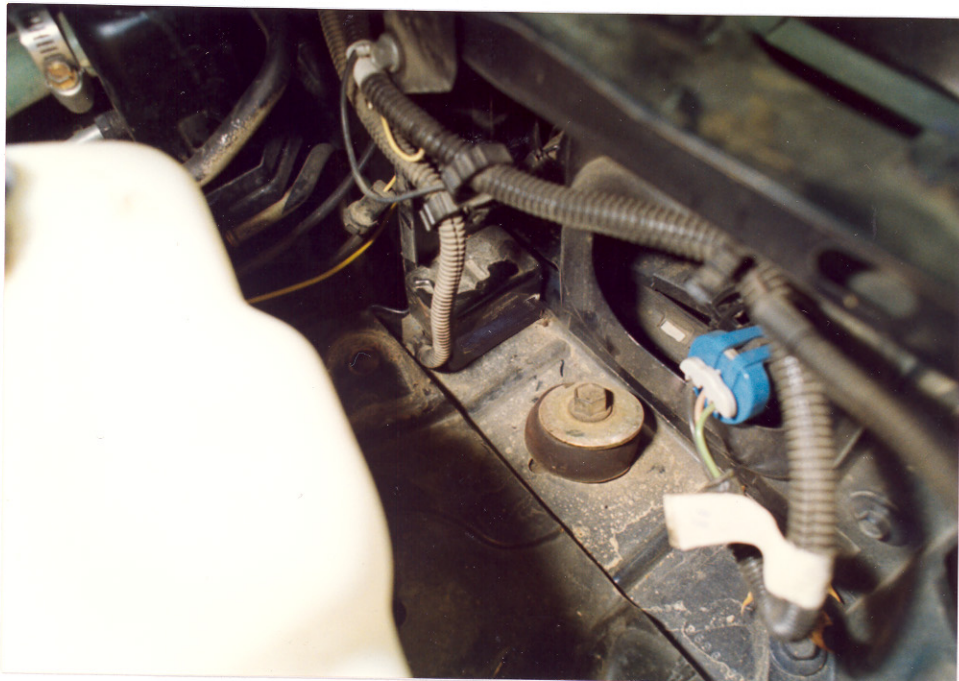
Right front discriminating sensor

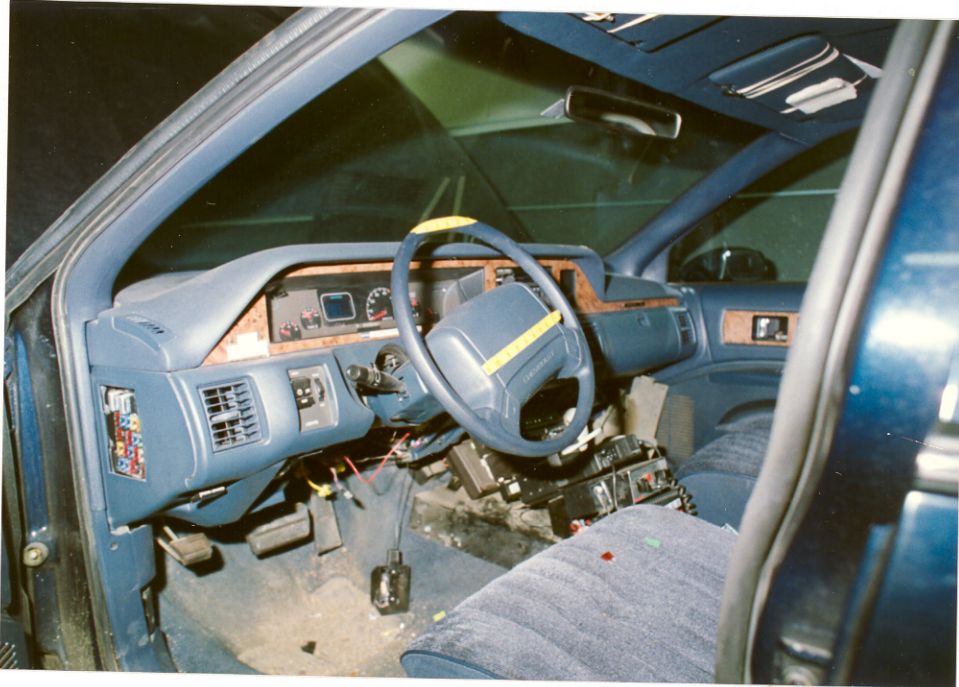
Overall view of the driver's seated position and the non-deployed
air bag module assembly

The driver of the 1992 Chevrolet Caprice was slightly out of position to his right at impact. He attempted to retrieve objects that had fallen between the front seats and against the emergency light switch panel. The driver had the seat adjusted to a mid track position and the tilt steering wheel set to a center position. He was not wearing the manual 3-point lap and shoulder belt system, however, he was wearing a bullet proof vest which consisted of 14 layers of Kevlar under his police uniform.

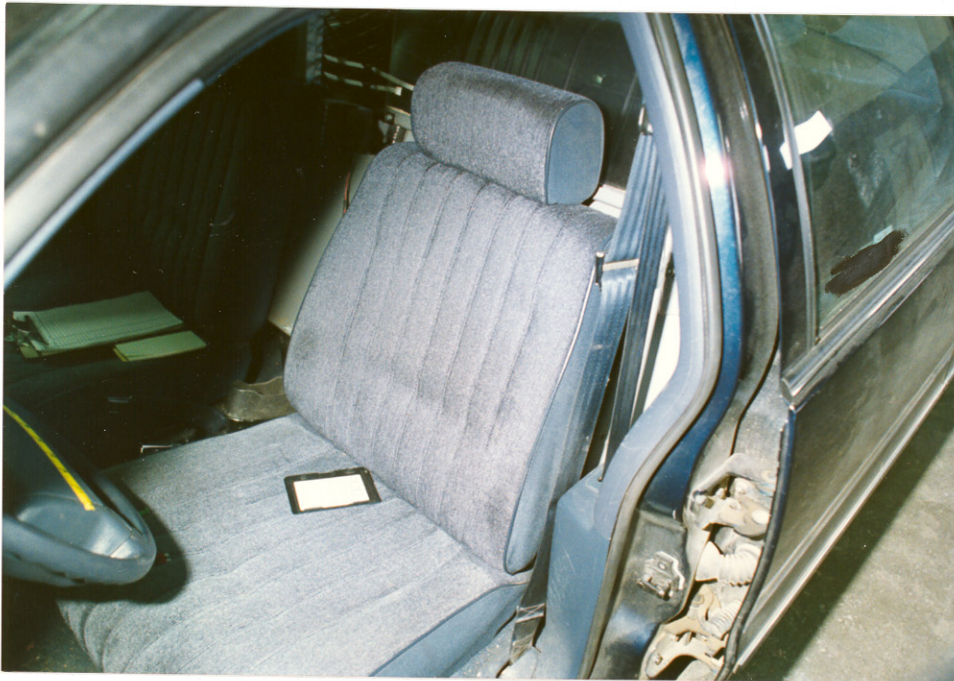
Driver's seat configuration and the manual 3-point belt system

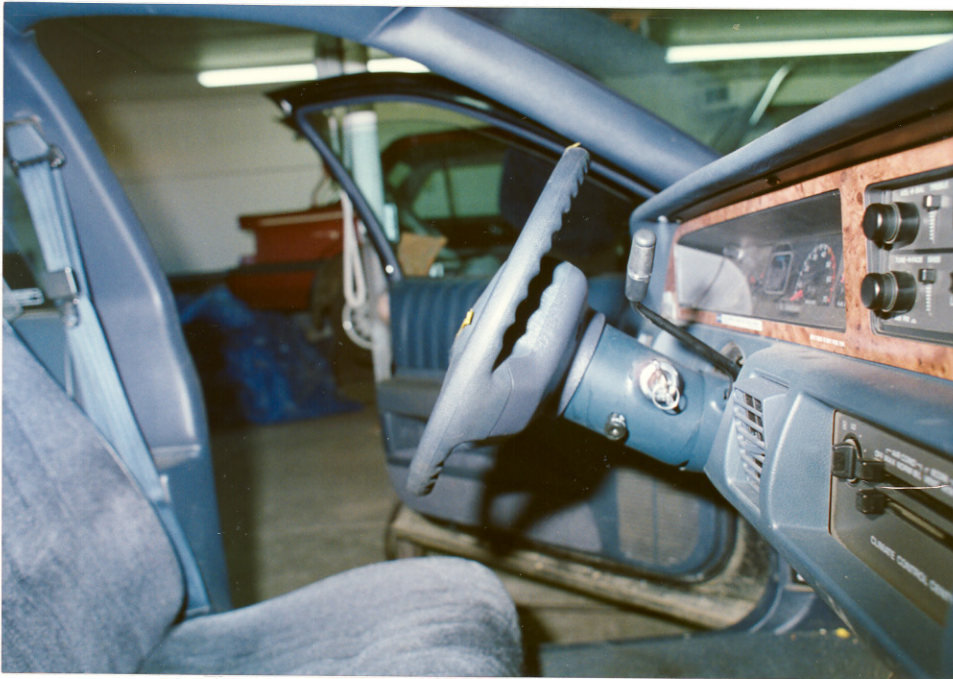
Perpendicular view of the steering wheel rim with slight deformation to the upper rim

The interior of the Chevrolet Caprice sustained minor damage that was associated solely with occupant contact. The unrestrained driver initiated a forward trajectory in response to the 12 o'clock impact force and loaded the steering wheel rim and air bag module assembly. His loading force minimally displaced the upper steering wheel rim 0.6cm (.25") forward and compressed the energy absorbing steering column 2.5cm (1"). Prior to our inspection, the body shop disassembled the knee bolster and the shear capsules (blocks removed) to inspect the column for damage. There was no damage to the bolster assembly.

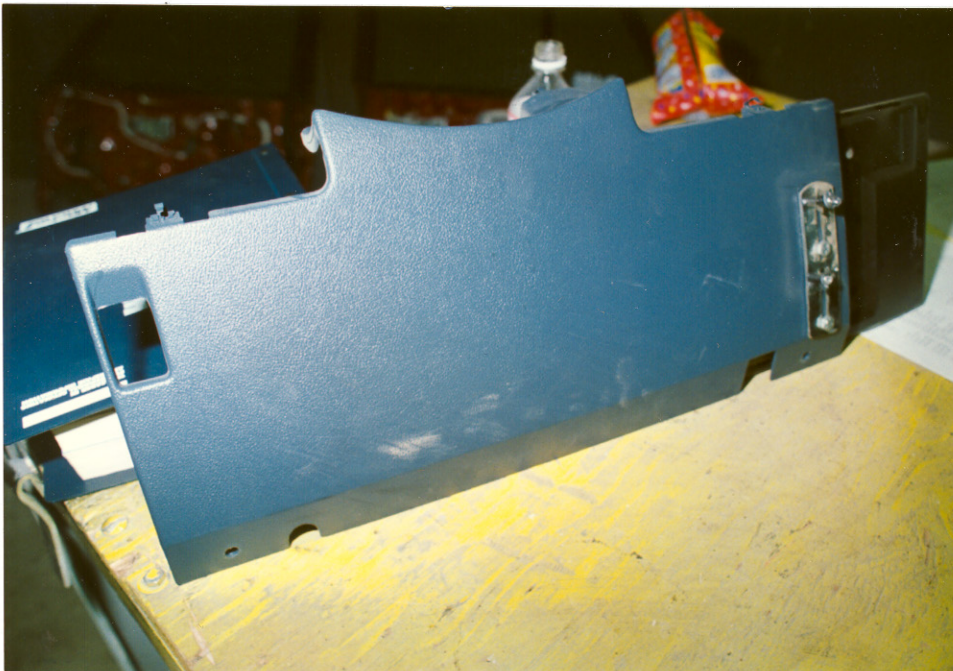
Knee bolster cover removed from vehicle

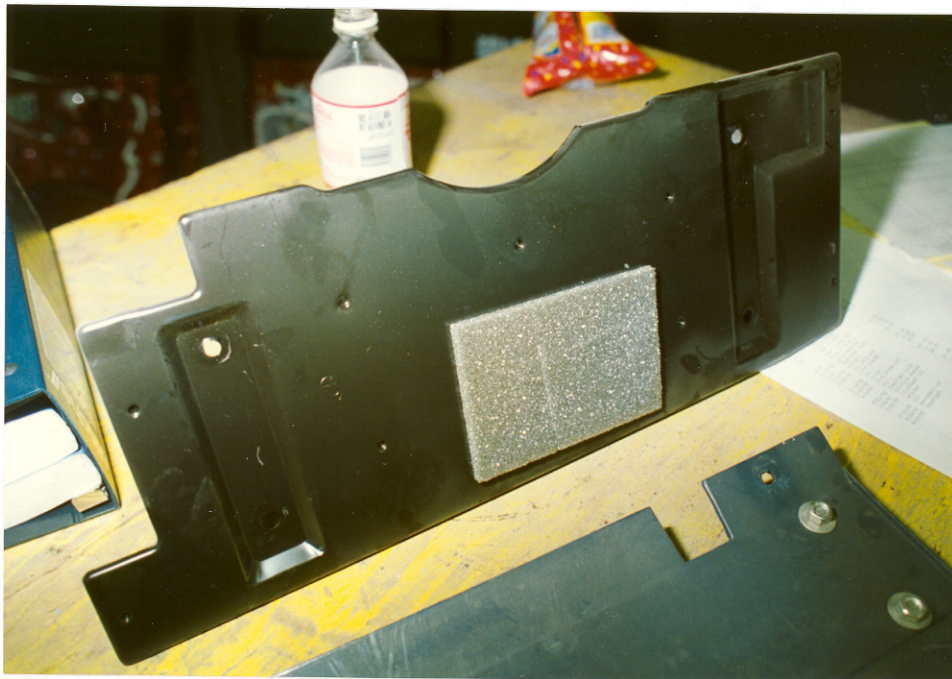
Knee bolster reinforcement

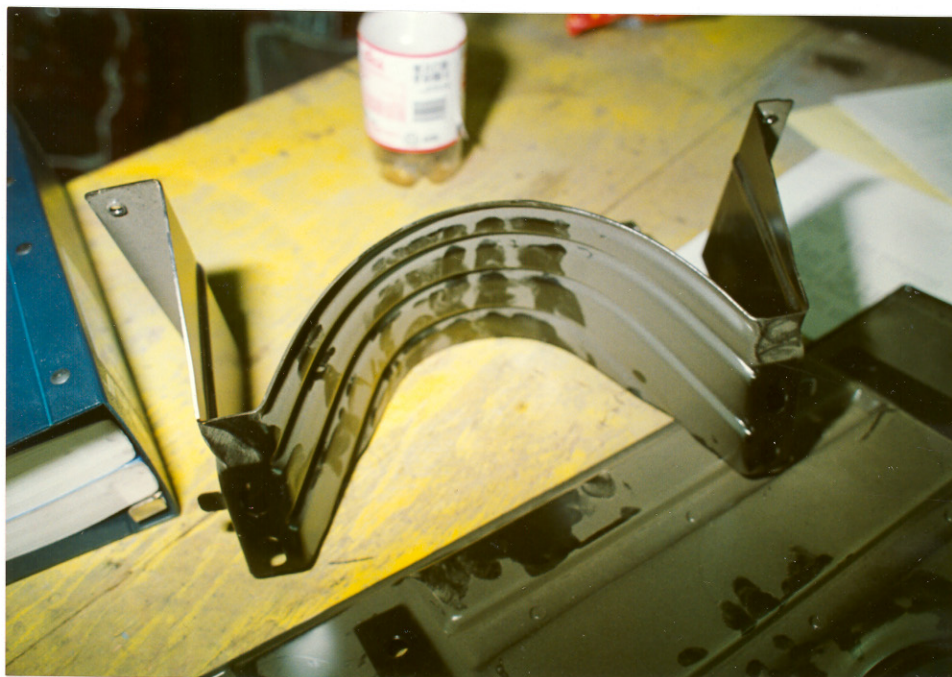
Knee bolster deflector bracket

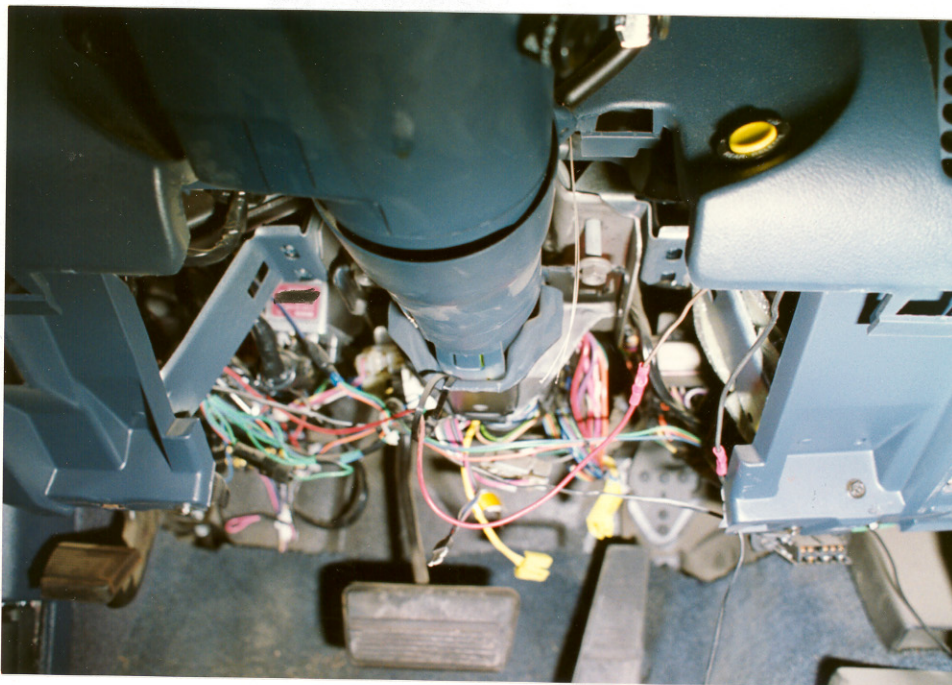
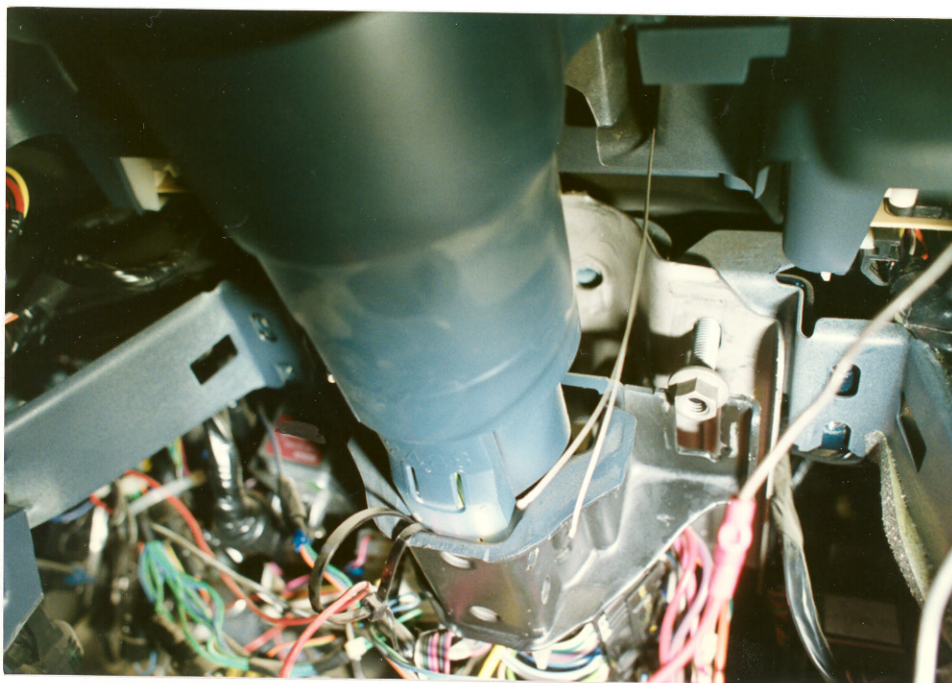
Steering column shear capsule compression (blocks removed)
and SIR Diagnostic Energy Reserve Module (DERM)

The SIR indicator lamp in the crash involved Chevrolet Caprice did not flash a fault code following the crash. The lamp reportedly flashed for a 6-8 second period then went out and stayed out when the ignition key was placed in the run position. This sequence indicates that the system is armed and operational. Prior to our inspection of the vehicle, the body shop had removed the battery from the vehicle to check for underlying damage. During our inspection process, the battery was reinstalled in the vehicle and the DERM was tested using the indicator lamp. With the ignition switch placed in the run position, the lamp flashed 7-9 times then went out and stayed out. This sequence indicates a normally operating system.

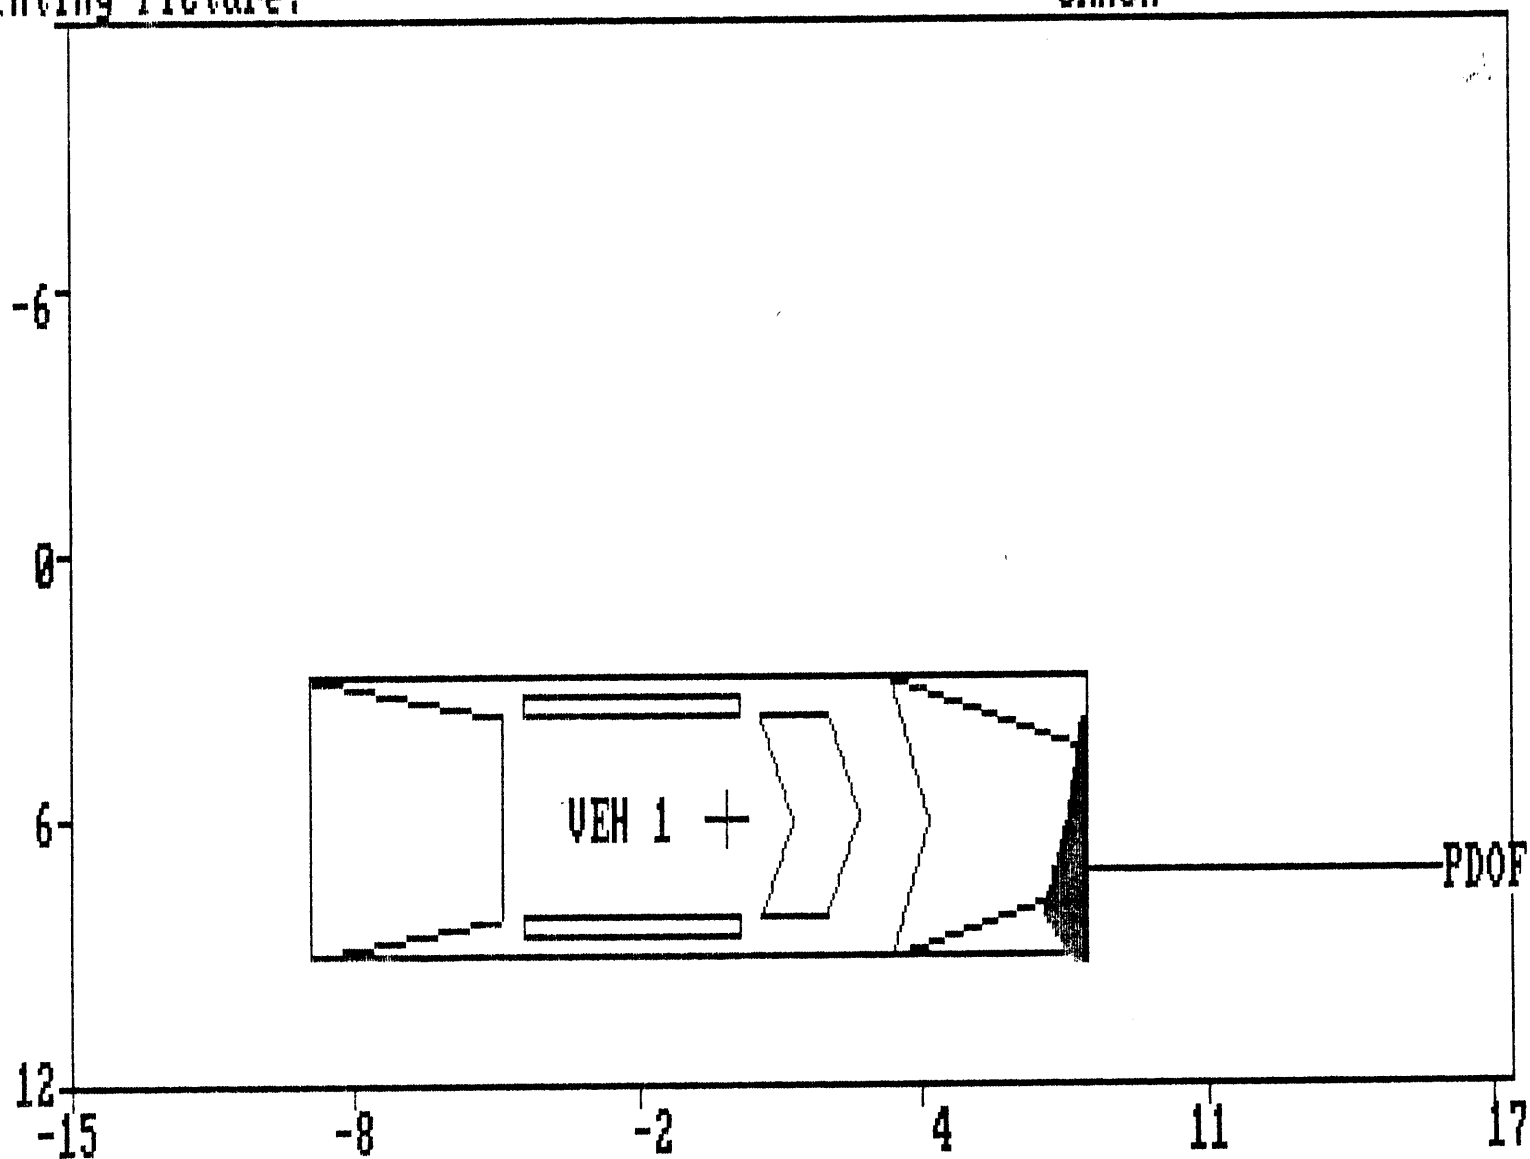
DAMAGE DESCRIPTION

SPEED CHANGE (DAMAGE)	IMPACT SPEED (DAMAGE AND SPINDOUT)
VEHICLE #1		
TOTAL	21 KPH (13 MPH)	23 KPH (14 MPH)
LONGITUDINAL	-21 KPH (-13 MPH)	23 KPH (14 MPH)
LATITUDINAL	0 KPH (0 MPH)	0 KPH (0 MPH)
PDOF ANGLE	0 DEGREES	
ENERGY DISSIPATED =	33609 JOULES (24786 FT-LB)	
VEHICLE #2		
TOTAL	0 KPH (0 MPH)	0 KPH (0 MPH)
LONGITUDINAL	0 KPH (0 MPH)	0 KPH (0 MPH)
LATITUDINAL	0 KPH (0 MPH)	0 KPH (0 MPH)
PDOF ANGLE	0 DEGREES	
ENERGY DISSIPATED =	0 JOULES (0 FT-LB)

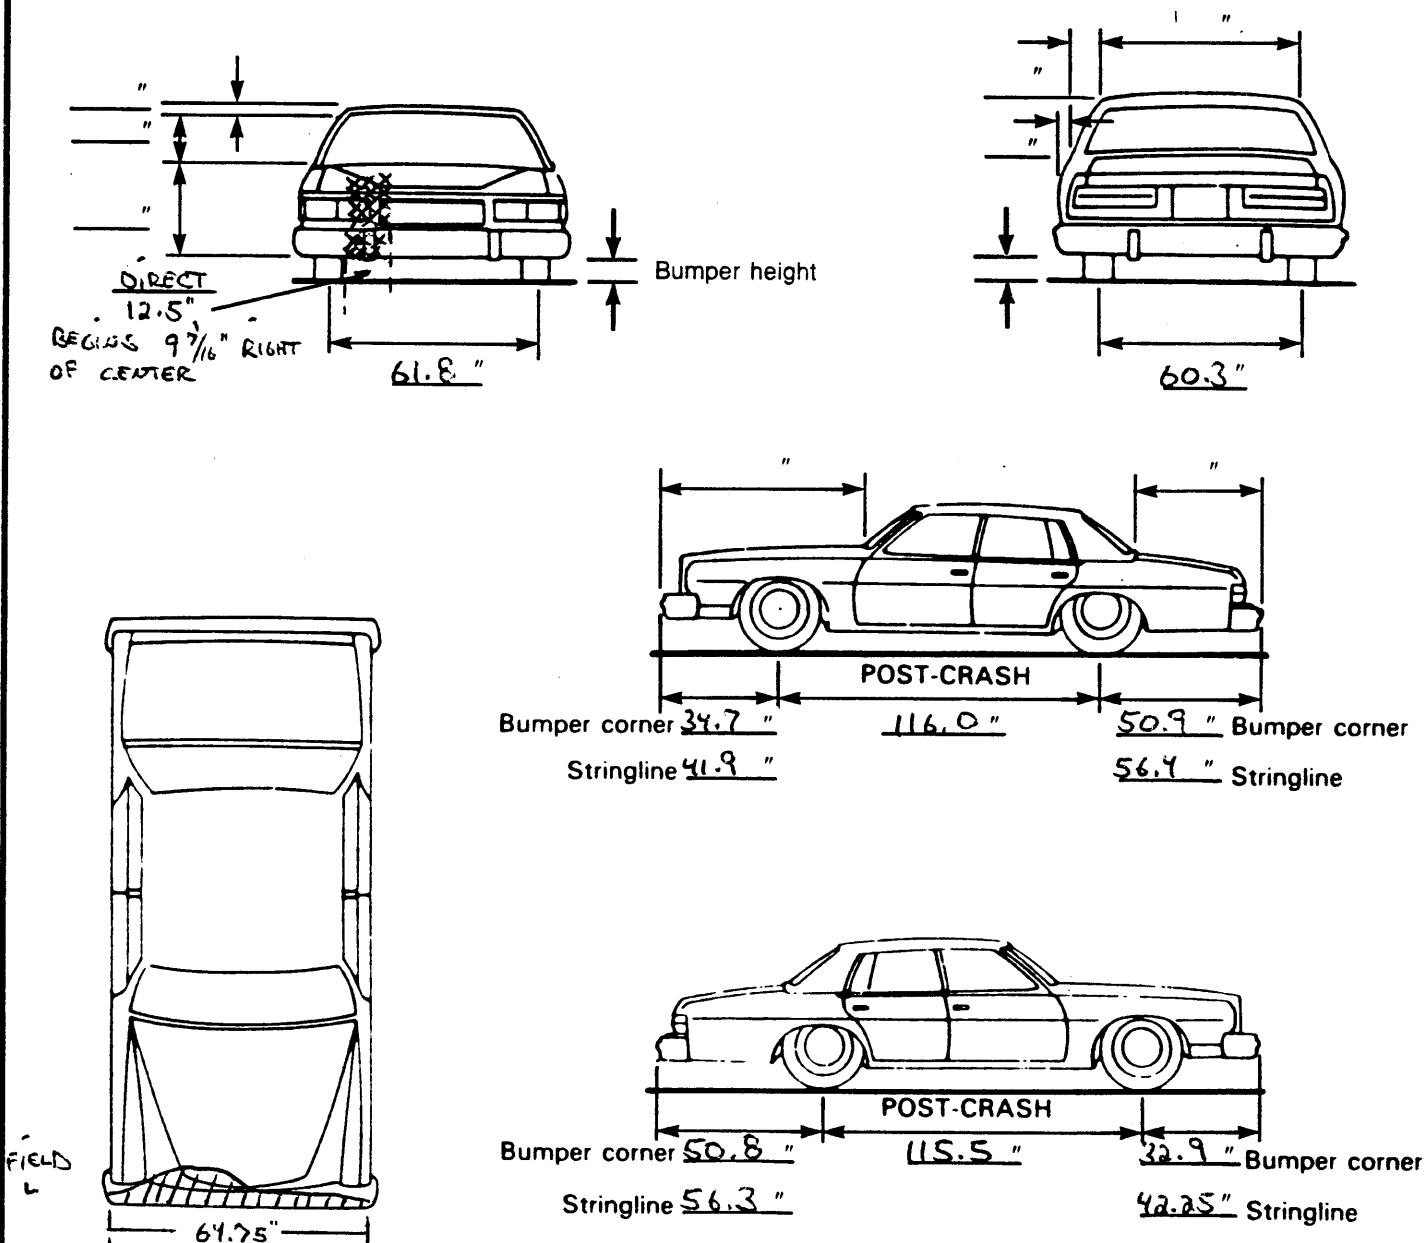
VEHICLE DAMAGE SKETCH

Specific Impact No.	Location of Direct Damage	Location of Field L
1	ON FRONT BUMPER FACIA, STARTS	FULL BUMPER WIDTH, 164.5 CM
	23.9 CM (R) OF CENTER, EXTENDS	(CORNER TO CORNER)
	31.8 CM TO RIGHT

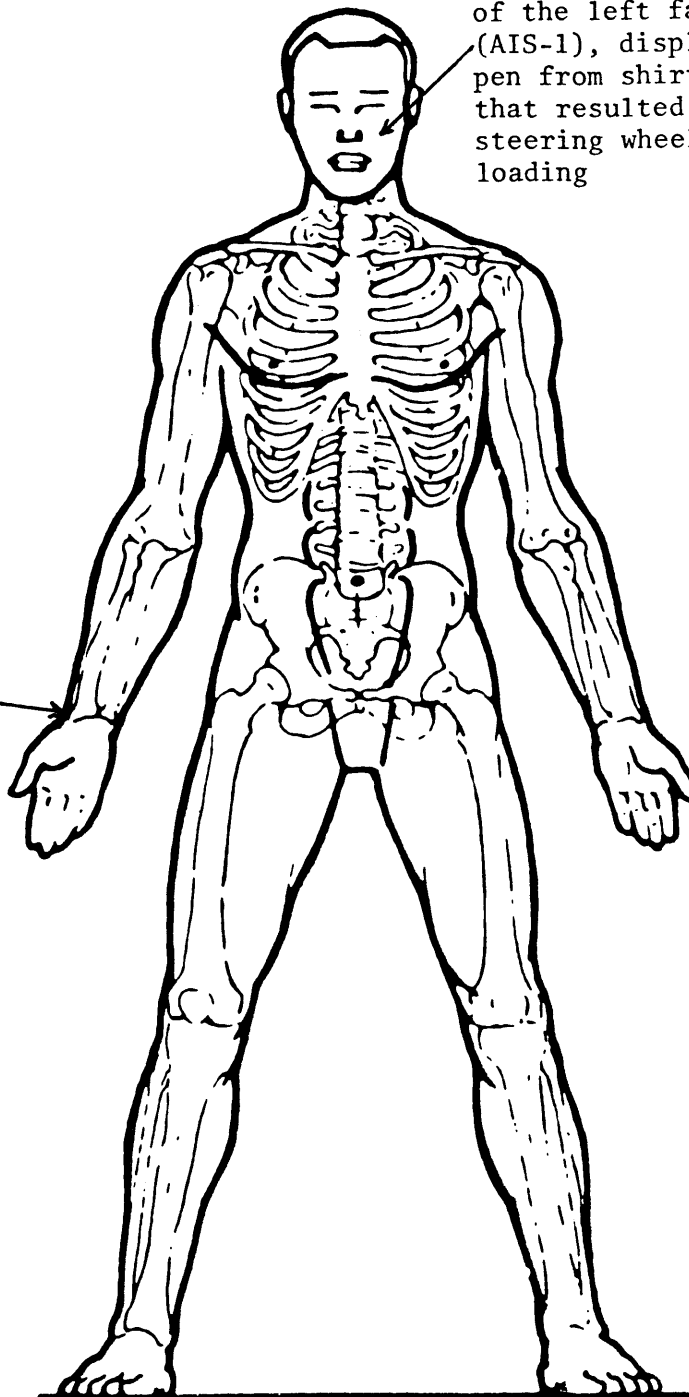
Small abrasion to the
dorsal aspect of the
right wrist (AIS-1),
center mounted
radio equipment

The driver responded to the 12 o'clock impact force by initiating a forward trajectory. His right hand and wrist area contacted the center mounted police radio units which resulted in an abrasion to the dorsal aspect of the right wrist. There was no damage or visible contact evidence to the radio units. His thoracic and upper abdominal areas loaded the steering wheel rim and the non-deployed air bag module assembly. The driver's loading force compressed the energy absorbing steering column 2.5cm (1") and deformed the upper rim approximately 0.6cm (.25"). His loading force against the steering assembly was partially absorbed and distributed by the Kevlar vest. He did, however, sustain compression of the upper abdominal area which resulted in brief traumatic apnea (loss of breath). The thoracic loading displaced a pen from the driver's left shirt pocket. As the pen was displaced, his head probably rotated downward and contacted the pen which produced a superficial laceration of his left face.
